Restoring a Burnt Heritage PTPN X Building in Surabaya

T. Ratna Darmiwati

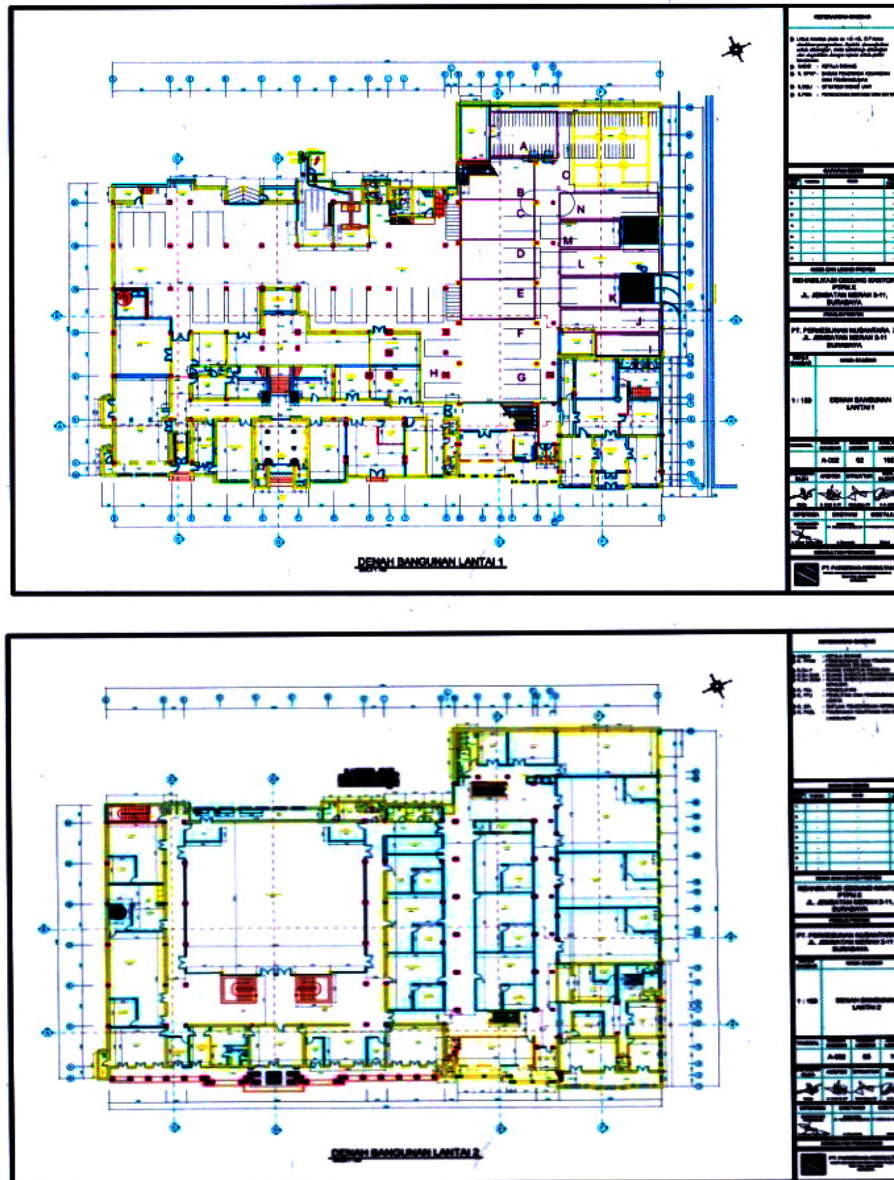
Figure 3 PTPN X Building (the first and the second floor design), by CV. Arsitektur Spasial Nusa Consultant [4].

There are four main activities involved in this research, such as a library search, survey, interview, and consultation, as a part of the building development process as shown in the following flow-chart in Figures 2 and 3. Finding the right literature for theoretical references is done via library search. The library search is the first activity in this research to obtain a complete, chronological overview of the building development and sources of historical materials in the colonial era. After the library search, the next activity in this study is the survey. Since 60% of PTPN X building was destroyed by fire, doing a survey of other

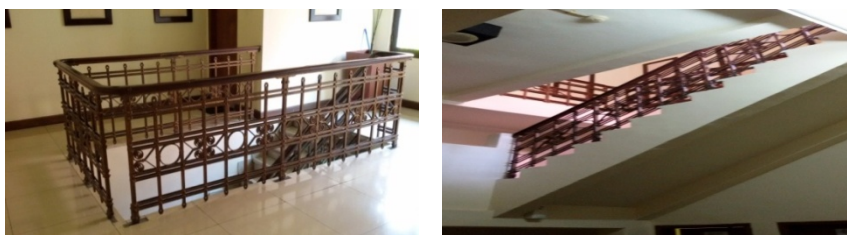
1. Basement of the building: it has excellent sanitation system. There are pumps and generators that still work well in the basement level.
2. Its main building has emergency exits through three stairways with direct exit to the basement for the safety of the Board of Directors in the case of a fire (Figure 4).

Figure 4 The stairways at PTPN X building/Source of observation research.

3. The second floor of PTPN X building:
This floor is where the offices of the Board of Directors/BOD (President Director, Finance, Operations and Marketing Directors) and Corporate Secretary are located. The BOD meeting rooms and the living room are located on the same floor. In addition, there is a Primary Multipurpose room, Corporate Finance room, Warehouse for Records, Janitor area and toilets. All of these rooms on this floor were rebuilt in accordance with the original heritage building design (the design in Figure 4).

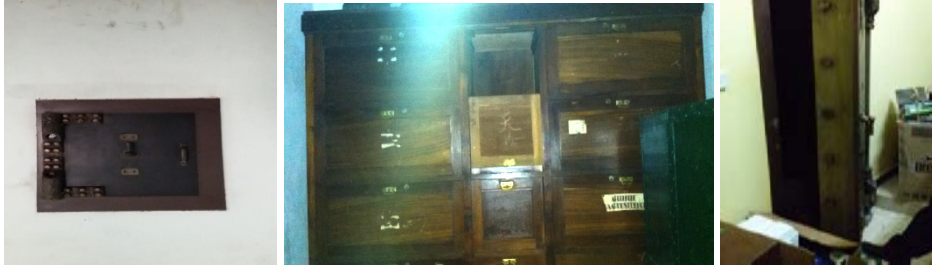
3. The colonial building is equipped with security systems and a hidden bunker to protect the safe storage of money and important documents of the

Dutch plantation office, and to protect the employees from external disturbances (there is a way to escape for employees that flow to the river which is located in outside of the office) (Figure 5).

Figure 5 The bunker at PTPN X building/Source of observation research.

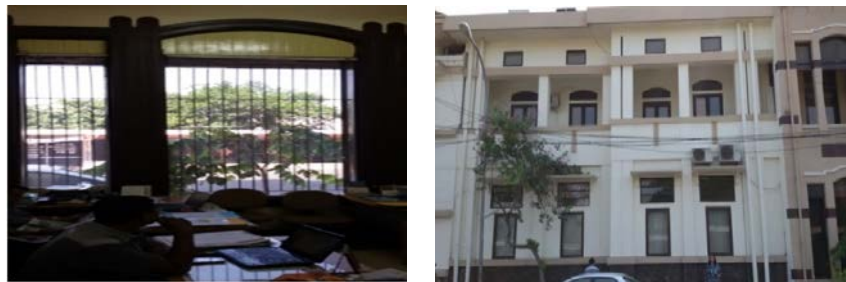
4. It also has galleries throughout the building with an excellent ventilation system, dormer for lights especially in the middle section of the building, and special ornaments depicting the plantation process starting from the planting stage until the harvest, which is well reflected on its glazing glass (Figure 6).

Figure 6 The type of ventilations of PTPN X Building/Source of observation research.

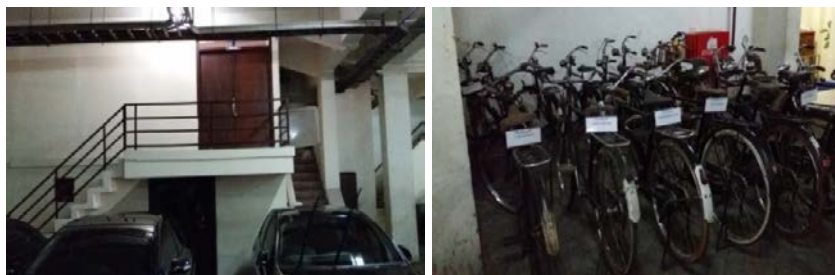
This floor is used for parking space of the Directors' and Employees' cars and motorcycles, storage area, toilets and janitor space, building pump and electricity generator space. The floor design is based on the original building design (Figure 8).

Figure 8 The parking space in the basement/Source of observation research.

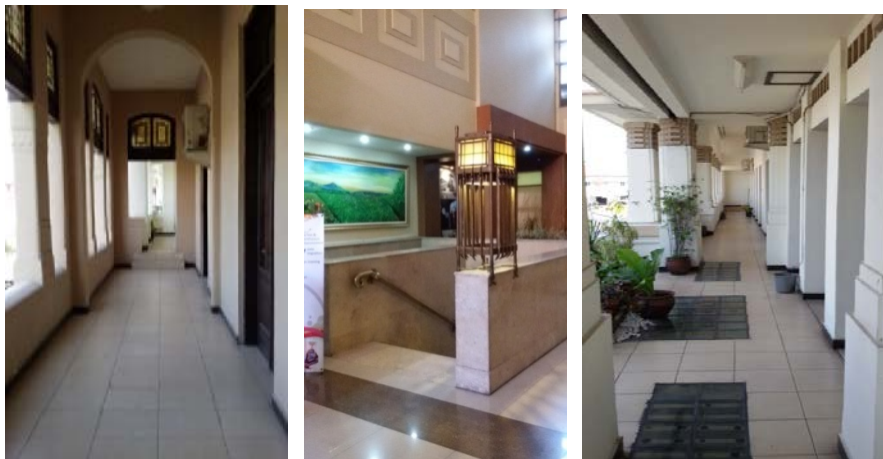
4. Physical building Finishing:
All the physical building finishing was customized to the Dutch colonial building original design. Authentic ornaments were applied to the building walls with synergic glass colors and patterns. All of the Dutch colonial heritage furniture is still functioning properly, including the safe for storing the company documents and the large cupboards for the plantation office archives that are located on the first and second floor. The finishing of the entire building includes the space for the sanitary and plumbing systems, which was done in accordance with the original building finishing (the design in Figure 10).

Figure 10 The physical of PTPN X building finishing/Source of observation research.

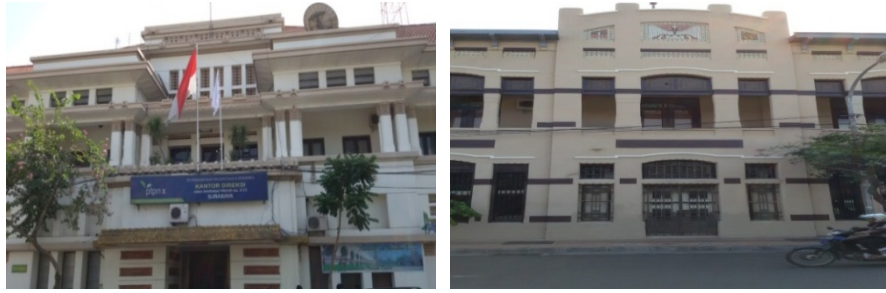
5. Roof Finishing:
The construction material used for the roof was stainless steel, instead of high quality wood materials as was in the original building construction. This is due to the reason that finding high quality wood material with the same specification as the original roof construction was not possible (Figure 11).

Figure 11 The Roof of PTPN X building/Source of observation research.
