## Seismic Behavior of Tunnel Form Building under Lateral Cyclic Loading

**Abstract.** A three-story single-unit tunnel form building (TFB) was designed using a non-seismic code of practice (BS 8110). Two one-third scale test models were constructed and tested under in-plane lateral cyclic loading and out-of-plane lateral cyclic loading, respectively. The specimens were tested at  $\pm 0.01\%$ ,  $\pm 0.1\%$ ,  $\pm 0.25\%$ ,  $\pm 0.5\%$ ,  $\pm 0.75\%$ ,  $\pm 1.0\%$ ,  $\pm 1.25\%$ ,  $\pm 1.5\%$ ,  $\pm 1.75\%$ ,  $\pm 1.8\%$ ,  $\pm 1.9\%$  and  $\pm 2\%$  drifts, after which severe cracks were observed on the wall-slab joints and wall panels. Subsequently, the damaged specimens were repaired and retrofitted by wrapping carbon fiber reinforced polymer (CFRP) around the damaged walls and affixing steel plates and steel angles at the wall-slab joints using several different repair and retrofitting schemes. The repaired specimens were retested using the same drifts. The comparison of the seismic behavior between unrepaired and repaired specimens was made based on visual observation of damage, hysteresis loops, lateral strength capacity, stiffness, ductility, and equivalent visco

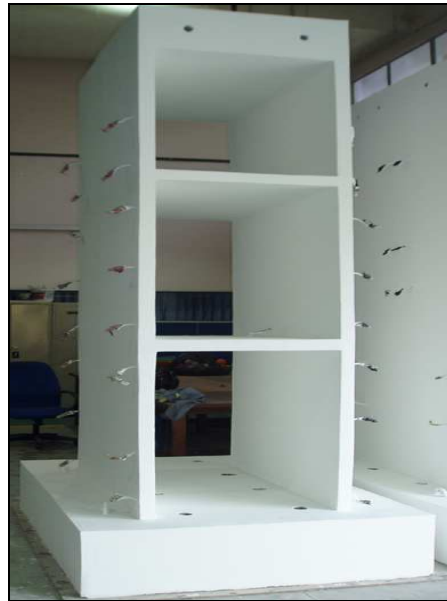
**Figure 3** Isometric view of TFB model ready for experimental testing.

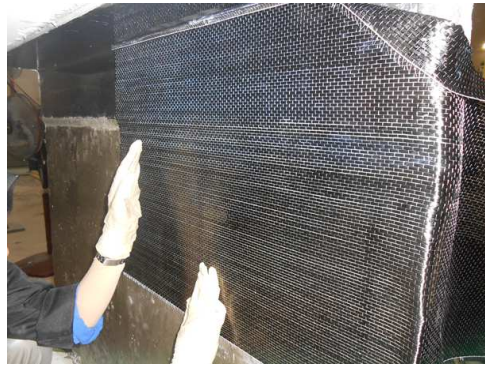
**Figure 4** Repair and retrofitting process of test model using CFRP fabric.

After the two specimens were tested under in-plane and out-of-plane lateral cyclic loading, respectively, the specimens were repaired and retrofitted using different repair and retrofitting schemes depending on the severity of the damage. The first TFB specimen, which had been tested previously under in-plane lateral cyclic loading, was repaired and retrofitted using CFRP, with a steel plate and a steel angle. Figure 4 shows the process of repairing and retrofitting the TFB specimen by affixing the steel plate and the steel angle at the wall-slab joint and then wrapping the whole shear wall with CFRP. The characteristic tensile strength of CFRP is 2800 MPa, the Young modulus  $E = 165 \text{ kN/mm}^2$ , and density is  $1600 \text{ kg/m}^3$ . The second specimen, which had been tested under out-of-plane lateral cyclic loading and had suffered severe damage at the wall-slab joints, was repaired using a steel plate and a steel angle. Then, this specimen was re-tested using the same loading pattern before repairing it, until more cracks were observed at the outer and inner wall. Finally, the damaged wall panel was repaired again using CFRP fabric, and retested for a third time. A comparison was made between the unrepaired and repaired specimen based on visual observation damage, hysteresis loops, stiffness, ductility, and energy dissipation. Table 1 shows the amount of drift imposed on the unrepaired and repaired test models under in-plane and out-of-plane lateral cyclic loading.

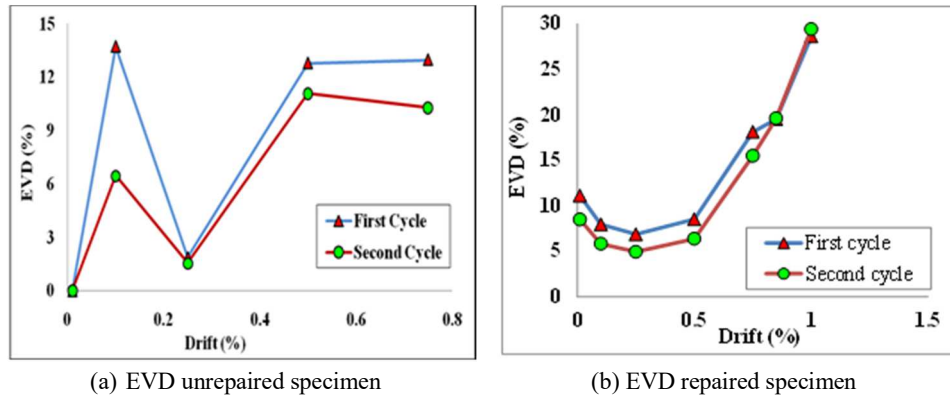
Figure 7 Comparison of EVD between unrepaired and repaired specimen.

where  $E_D$  = energy dissipated under one complete cycle by calculating the total area under the hysteresis loops using the area under the trapezium and strain energy  $E_{S0}$  by calculating the area of the triangle under maximum lateral load and maximum lateral displacement. Normally, the equivalent viscous damping for the first cycle is higher than for the second cycle. Figure 7(a) shows the equivalent viscous damping of the unrepaired specimen for the first and second cycle. Meanwhile, Figure 7(b) shows the equivalent viscous damping for the repaired specimen for the first and the second cycle. The maximum equivalent

viscous damping occurring in the repaired specimen was 30%, which is due to the larger area of the hysteresis loops in the repaired specimen when compared with the unrepaired specimen. The data analysis of the results will be discussed in the next section for the second specimen, which was tested under out-of-plane lateral cyclic loading.

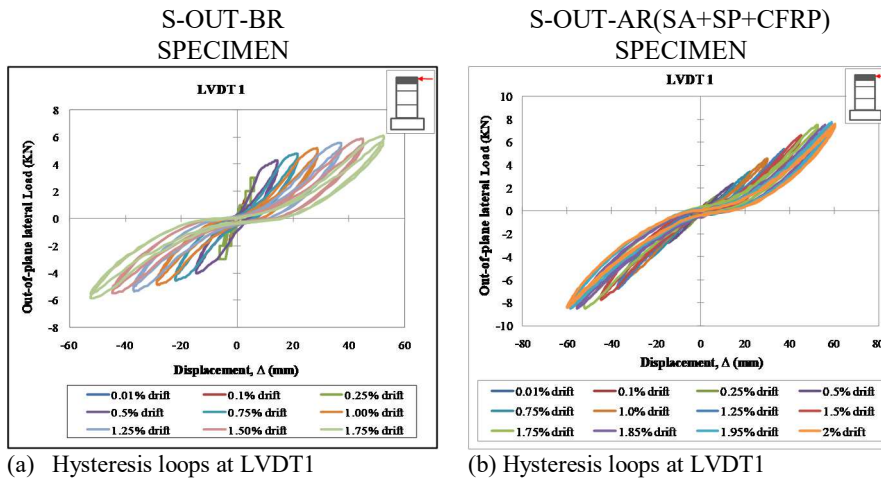
**Figure 9** Comparison of hysteresis loops between unrepaired and repaired specimens.

Figure 9 shows a comparison of the hysteresis loops of the test model, which had been repaired and retested under out-of-plane lateral cyclic loading. The total area of the hysteresis loops for the unrepaired S-OUT-BR specimen was larger than for the S-OUT-AR(SA+SP+CFRP) repaired specimen, as shown in

Figure 9(a). However, most of the hysteresis loops from the repaired specimen shown in Figure 9(b) were very slim, where less of energy was dissipated during testing. Moreover, the highest value recorded by the load cell under out-of-plane lateral strength capacity was 8 kN, obtained from the S-OUT-AR(SA+SP+CFRP) specimen. Meanwhile, the out-of-plane lateral strength capacity of the S-OUT-BR specimen was 6 kN. Therefore, the out-of-plane lateral strength capacity was increased by 33.3% after the specimen was repaired and retrofitted using the steel plate, the steel angle and CFRP.

The hysteresis loops of the S-OUT-BR unrepaired specimen and the S-OUT-AR(SA+SP+CFRP) unrepaired specimen shown in Figure 9 were used to calculate the seismic performance of the TFB test model under out-of-plane lateral cyclic loading. The comparison of seismic performance based on elastic stiffness ( $K_e$ ), secant stiffness ( $K_{sec}$ ), ductility and equivalent viscous damping was analyzed and investigated.
