# The Effect of Linear Low-Density Polyethylene and Palm Kernel Shell Ash Mixture on the Physical, Mechanical and Degradation Properties of Paving Blocks

Chasri Nurhayati\*, Nesi Susilawati, Tri Susanto, Winda Marthalia.  
Aditya Krisna Nugroho & Ahmad Paisan Pane

Palembang Institute for Industrial Research and Standardization,  
Ministry of Industry of The Republic of Indonesia, Jalan Perindustrian II No 12,  
Palembang 30152, Indonesia

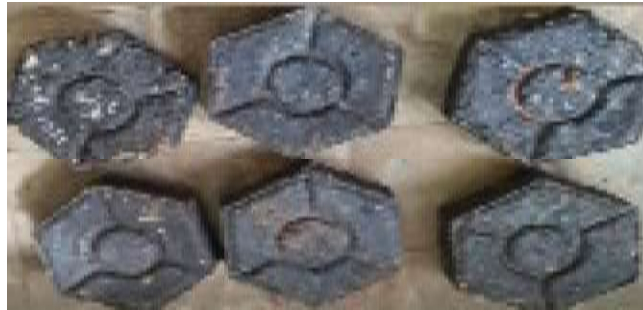
**Figure 1** Plastic paving blocks on day 0.

The physical appearance of the paving blocks on day 0 and day 365 is shown in Figures 1 and 2.

The LLDPE and PKSA paving blocks had a smooth surface and were not brittle on day 0. Table 1 shows the physical surface appearance of the mixtures with different compositions of LLDPE and PKSA as filler. After 365 days, the surface had become rough with more voids, more cracks and more brittleness. The LLDPE had higher elasticity with addition of PKSA filler, and its physical performance improved. After 365 days the paving blocks were rougher, had cavities and more cracks on the surface, and were more fragile because of the degradation by bacteria/microorganisms and air/ozone exposure [20,21].

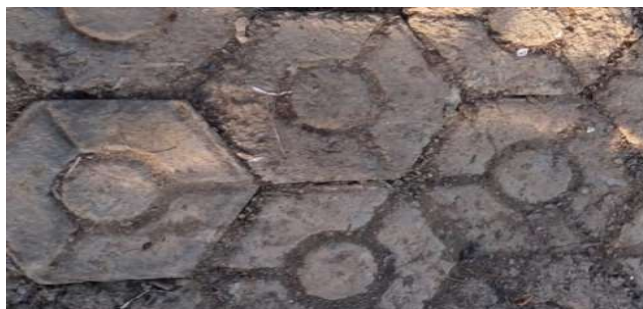
**Figure 2** Plastic paving blocks on day 365.

The oxidation process caused surface cracking and brittleness in Refs. [22,6]. This was confirmed by the result of the present research. When the surface of the plastic paving block oxidizes, it causes cracking and brittleness due to the lack of antioxidants in the composite [23,22]. In addition, the process and dispersion capability of the filler within the LLDPE matrix may not be very good, so that surface attacks cannot be impeded. This result is supported by Suharty [21], who studied paving blocks with a composition of polypropylene waste:acrylic acid:rice husk powder (7:0:3), which were stored for 4 months in the ground at normal air temperature. This treatment reduced the weight of the paving blocks by 12%.

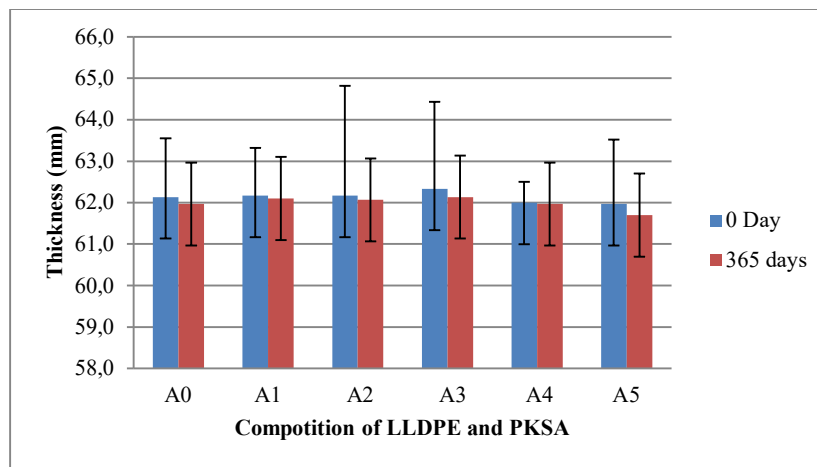
**Figure 3** Thickness degradation of LLDPE:PKSA composites from day 0 to day 365 .

Based on the graph above, it can be determined that the product's thickness did not change significantly among all combinations. This result is consistent with Ref. [14], which states that the thickness of the paving blocks was not significantly altered after treatment. The paving block product was replaced with a metal mold of about 10 x 20 x 6 cm (length x width x thickness), a hexagonal shape (with an additional hexagonal engraving in the middle) and pressed at 200 kg/cm<sup>2</sup> with a hydraulic press for about 5 minutes, after which the product was soaked in water for 8 minutes before testing.

The graph of thickness degradation of the LLDPE:PKSA composite from 0 day to day 365 is shown in Figure 3.

The test results for the thickness of the paving block ranged from 62.1 mm to 62.0 mm on day 0 and 62.0 mm to 61.7 mm on day 365. This means it did not change significantly despite undergoing degradation. PKSA as an additional material reduced the thickness of the composites, as can be seen in the results for treatments A<sub>4</sub> (90:10) and A<sub>5</sub> (87.5:12.5). It is known that the longer the degradation period, the greater the thickness reduction, especially for composites with higher PKSA content. The maximum thickness reduction was 0.48% (Figure 3). According to SNI 03-0691-1996 [24], the minimum thickness of concrete road paving blocks is 60 mm with a tolerance of 8%. Therefore, the results showed that the final thickness still met the SNI standard. Zufahair *et al.* [26] used polyethylene thin plastic film made by dissolving ± 0.5 g of polyethylene in 15 ml of xylene solvent. They found that there was a reduction in yield strength after storage, which means that the weight of the plastic films was reduced by 2.33% over 30 days [26].

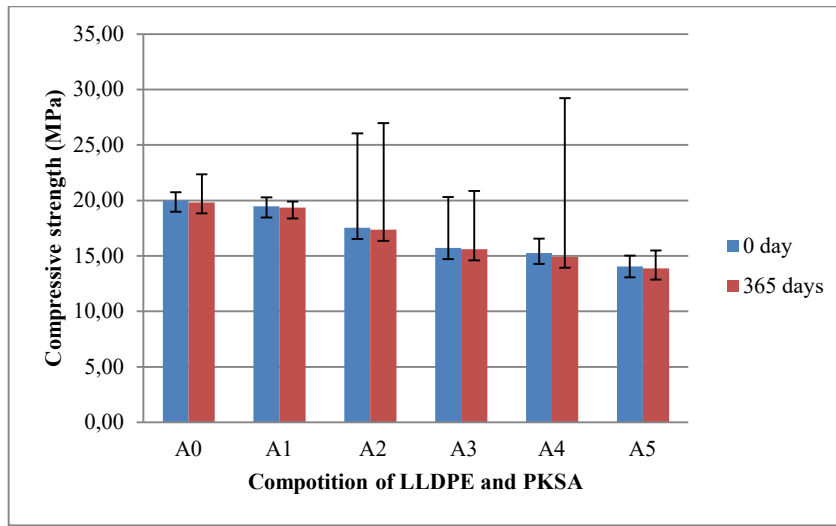
A graph for compressive strength degradation of LLDPE and PKSA paving blocks on day 0 and day 365 is shown in Figure 5. The highest compressive strength was found for treatment A<sub>0</sub>(100:0) and the lowest average strength was found for treatment A<sub>5</sub>(87.5:12.5) on day 0. Meanwhile, on day 365 the highest strength found was for treatment A<sub>0</sub>(100:0) while the lowest strength was found for treatment A<sub>5</sub>(87.5:12.5) (Figure 5). The addition of PKSA as filler reduces the compressive strength of paving blocks [13]. This is in line with the result of

**Figure 5** Compressive strengths of LLDPE and PKSA paving blocks.

our paving block compressive strength test, where the addition of PKSA reduced the compressive strength from day 0 to day 365 (Figure 4). This is also supported by the results from Olale [18], who made paving blocks using LLDPE, sand, and kaolin waste. The addition of 8% kaolin reduced the compressive strength by 11 kg/cm<sup>2</sup>. Furthermore, Oyetuji [13] made paving blocks with a composition of PP plastic waste and sand at 1:1, and melting point at 200 °C, which resulted in a compressive strength of 415 kg/cm<sup>2</sup>.

LLDPE is a resin consisting of molecules with a linear polyethylene backbone attached randomly by short alkyl groups. LLDPE has a density of 0.90-0.94 g/cm<sup>3</sup> [11]. The addition of PKSA is not only intended to minimize environmental problems caused by excessive plastic waste but also to optimize the water absorption capacity of the paving blocks [29]. For cement or concrete applications, PKSA filler contributes not only to the compressive strength but also to its hardness. Conversely, in recycled LLDPE composites, the PKSA may not disperse within the polymer and its process capability is severely limited due to the difference in polarity, size and density between the filler and the polyethylene [1,21,22,29]. PKSA contains silicon dioxide (SiO<sub>2</sub>), aluminum oxide (Al<sub>2</sub>O<sub>3</sub>), ferric oxide (Fe<sub>2</sub>O<sub>3</sub>), calcium oxide (CaO) and magnesium oxide (MgO). The PKSA used in this study, which came from boiler combustion at PT. Hevea MK I Palembang, Sumatra, Indonesia, had low humidity at 20.70%, while SiO<sub>2</sub> has a humidity of 34.37% [19]. Adding SiO<sub>2</sub> increases the compressive strength of cement raw materials, but it will decrease the compressive strength of polyethylene.

The small area of porosity in the paving block with treatment A<sub>0</sub> is in line with the high compressive strength value of 203.79 kg/cm<sup>2</sup> (Figure 5) and low water absorption of 0.06% [28] (Figure 4). From the EDX results at 1000x magnification for the paving blocks without the addition of PKSA (treatment A<sub>0</sub>) and without coating, the elements found were Pb (8.3%), Ca (5.53%), Cl (8.40%), O (10.74%) and C (67.00%). The majority was O and C and the minor elements were Pb, Ca, and Cl (Figure 8).

The large area of porosity for treatment A<sub>5</sub> (Figure 9) is in line with the lowest compressive strength value of 43.26 kg/cm<sup>2</sup> (Figure 5) and high water absorption of 0.84%, in Figure 3 [28]. From the EDX results at 1000x for treatment A<sub>5</sub> (87.5:12.5) without coating, the elements found were Rb (17.47%), Fe (2.31%), Ca (5.37%), Si (5.37%), Al (4.72%), O (22.74%) and C (41.43%). The major elements were C and O, and the minor elements were Rb, Fe, Ca, Si and Al (Figure 9).
