## **PENINJAUAN STATUS LINGKUNGAN EKSISTING SUNGAI MARIKINA, FILIPINA**

### ***REVISITING THE CURRENT ENVIRONMENTAL STATUS OF THE MARIKINA RIVER, PHILIPPINES***

**Marwin Crispino<sup>1</sup> and Eligia Clemente<sup>2</sup>**

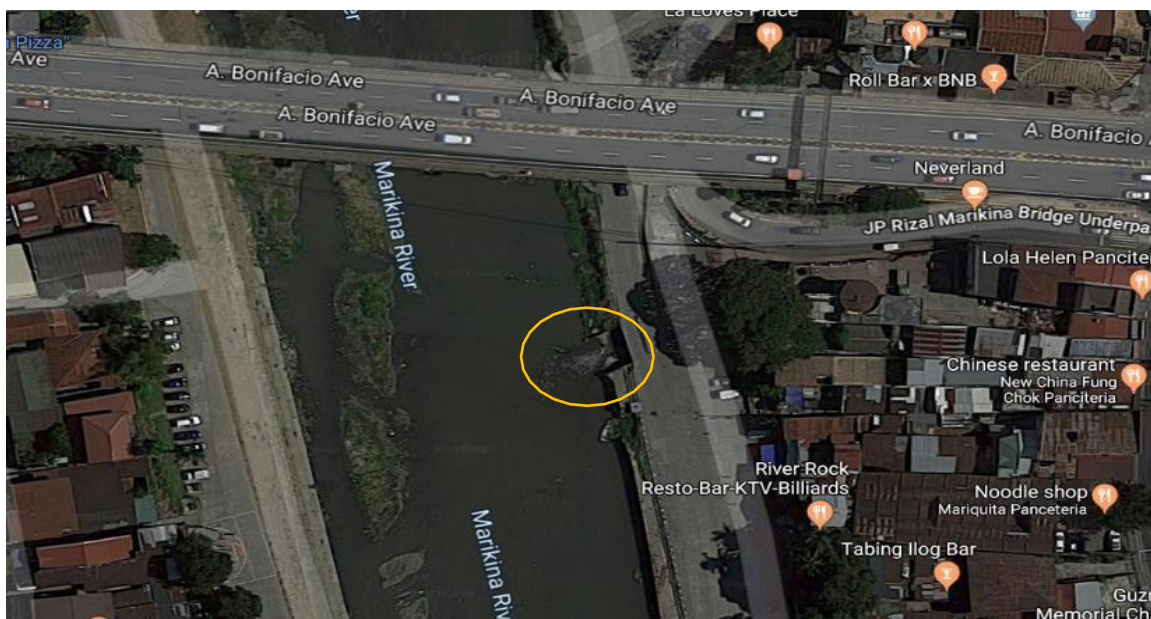
**Figure 1.** Site Location using Google Maps and Google Earth

As shown in figure 1, the sampling location is a double box culvert effluent along Marikina River which caters to approximately 315 hectares of mixed-use land in Marikina City. This 315-ha catchment area covers various *barangays* including portions of *Brgy. Sto. Nino*, *Brgy. Sta. Elena*, *Brgy. Concepcion Uno*, and *Brgy. San Roque*.
