## Drilling Strategy for Thick Carbon Fiber Reinforced Polymer Composites (CFRP): A Preliminary Assessment

**Abstract.** Carbon fiber reinforced polymer or CFRP composites are the epitome of high-performance materials in lightweight design. However, their machinability can be problematic due to non-homogenous and anisotropic material properties. This preliminary assessment emphasizes drilling strategy by using mechanical drilling and laser machining on 25.4 mm thick CFRP, which has not been investigated so far. In mechanical drilling, three drilling strategies were applied with the same parameters in order to assess the feasibility of drilling thick CFRP. The laser machining experiments were conducted to identify the potential of fiber laser machines to cut thick CFRP due to their superior laser beam quality. The results showed that choosing the appropriate drilling strategy in mechanical drilling is essential for reducing damage when drilling thick CFRP. Significant damage occurred in all experiments. The results are useful to define the relationships between machining parameters related to mechanical/laser drilling and hole/cut quality.

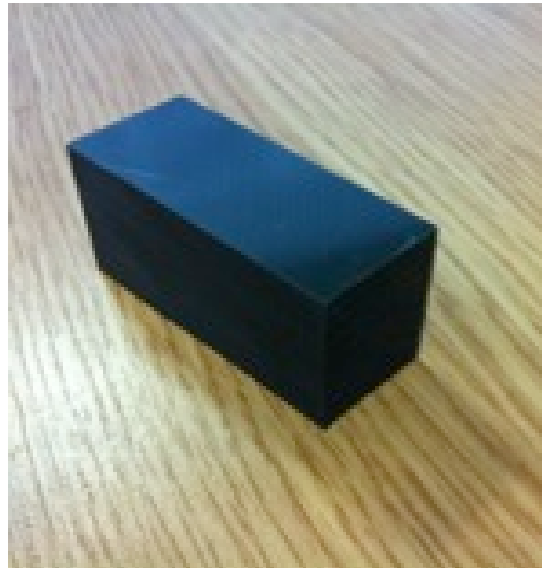
The mechanical drilling experiments were conducted on 25.4 mm thick CFRP composites (see Figure 1) in order to drill a  $\varnothing$  8mm hole (material sample size 50 (length) x 20 (width) x 25.4 (thick/height) mm) by using a 2-flute tungsten carbide drill bit (WC-uncoated  $\varnothing$  8 mm with a point angle and helix angle of  $118^\circ$  and  $35^\circ$  respectively) on a Takisawa MAC-V3 Machining Center (maximum spindle speed and power of 6,000 rpm and 5.6 kW, respectively) in

**Figure 1** CFRP specimen.

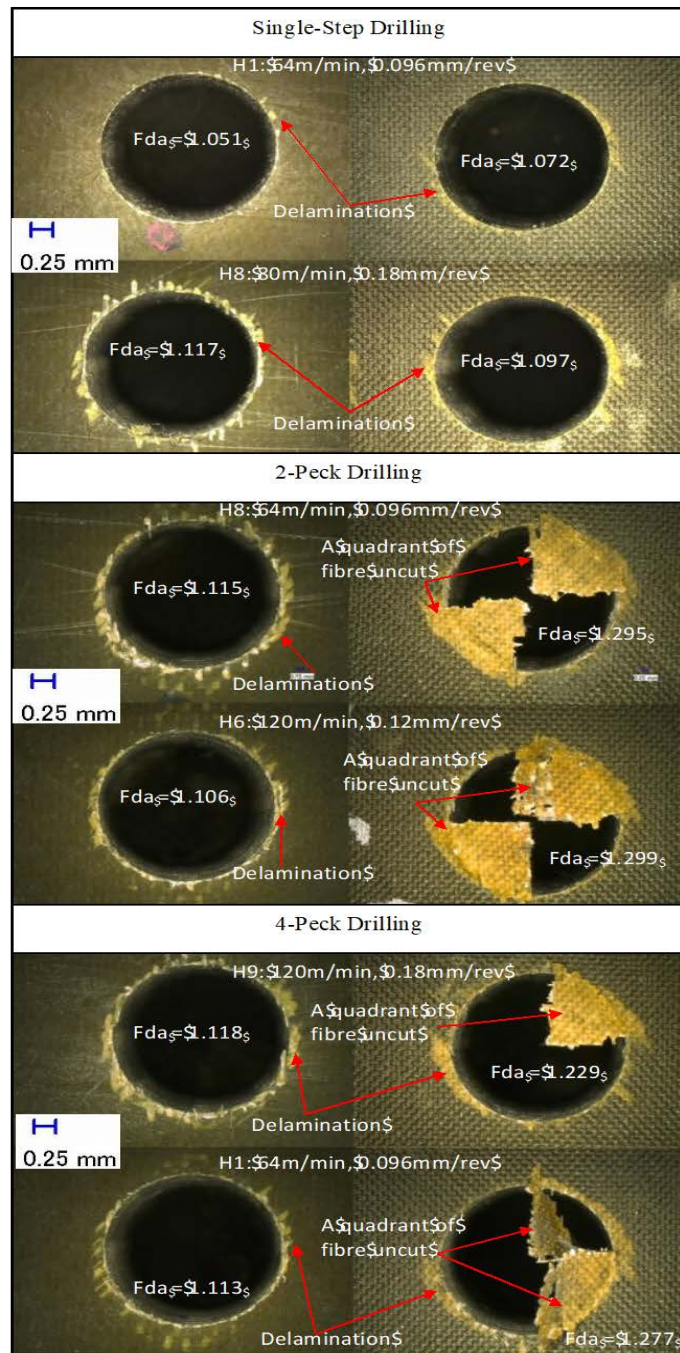
At this stage, the evaluation was only focused on the delamination factor without tool wear observation and to decide which drilling strategy achieved the best hole quality. Figure 5 shows samples of the hole entry (left image) and exit (right image) after drilling with three drilling strategies, i.e. peck drilling with 2 and 4 steps, as well as single-step. The holes depicted in Figure 5 were drilled in sequence, which means that the first hole was drilled with the lowest feed and the lowest speed, while the last hole was drilled with the highest feed and highest speed. In contrast, Figure 6 (the left image is the hole entry and the right image is the hole exit) shows the combination of feeds and cutting speeds where each hole was drilled in a random manner in order to establish if the hole quality is affected either by the cutting parameters solely or both from the cutting parameters and tool wear progression.

Visible damage was observed to all holes produced, particularly peel-up and push-down delamination. The hole defects became more serious as the number of steps of peck drilling increased, with most damage visible after 4-step peck drilling. The quality concern was confirmed when comparing two strategies, i.e. single-step and 2-step peck drilling. It is apparent from the pictures shown in Figures 5 and 6 that the most significant damage occurred at the hole entries. In these tables, the left hole is the entry side while the right one is the exit side. All damage and the adjusted delamination factor ( $F_{da}$ ) ratios are shown in both tables. Although the delamination at the hole entry generally appeared to be more severe compared to the damage produced at the hole exit, a closer inspection of the defects of the hole exit, such as delamination and overhanging/uncut fibers, in Figures 5 and 6 show that there was a similar trend there, i.e. damage along a certain quadrant area in most cases. In addition, the regular lines stretching out radially at these quadrant areas (as annotated in the table) is believed to be part of the heat affected zone, where the thermal conductivity of the carbon fibers is high compared to the surrounding matrix, thus encouraging the heat generated during the cutting process to spread out along the fibers.

Some damage also occurred at angles opposite the quadrant with the angle between  $180^\circ$  and  $90^\circ$  degrees, such as in the case of H6 and H8 (2-step peck drilling) in Figure 5. In addition, certain combinations of cutting speed and feed rate, such as in the case of H19 and H27 (4-step peck drilling) in Figure 5 and H10 and H15 (4-step peck drilling) in Figure 6, resulted in the bottom of the workpiece showing large areas of the bottom attached to the workpiece. This behavior is the same as in another research attempt [3], where the critical cutting angles occurred between  $180^\circ$  and  $90^\circ$  degrees where delamination and overhanging/uncut fibers occurred. All holes shown in both tables are from the perspective of the initial and final layer, whereby both layers possessed a woven-ply structure with no specific fiber orientation due to the bidirectional form. During the drilling process, the fibers were actually bent by the cutting edges and it was obvious that cutting perpendicular to the fiber direction caused significant damage.

Figure 5 Image results of drilling strategies in sequential manner.

This may have been caused by softening of the matrix, which allowed the fibers to elastically deflect during the cutting process and therefore not being fully cut by the tool. In addition to that, generation of drilling heat softened the matrix, which can compromise its shear modulus and relieve the radial stresses exerted over the fibers. Consequently, 2-step and 4-step peck drilling generated a large amount of heat as the tool was required to be taken in and out two or four times, while single-step drilling involves less interaction time between the tool and the workpiece. Furthermore, the matrix was unable to transfer the local strain perturbations efficiently to the fibers and failed to provide sufficient stability to the fibers against the cutting action of the twisting drill, the same as in other researches [5,6,17] on premature fiber debonding, slipping and fracture, dependent on the relative orientation of the fiber with respect to the cutting edge of the drill. This is supported by the evidence of the softened matrix on the hole boundaries. Thus, the drilling strategy affected the hole quality.

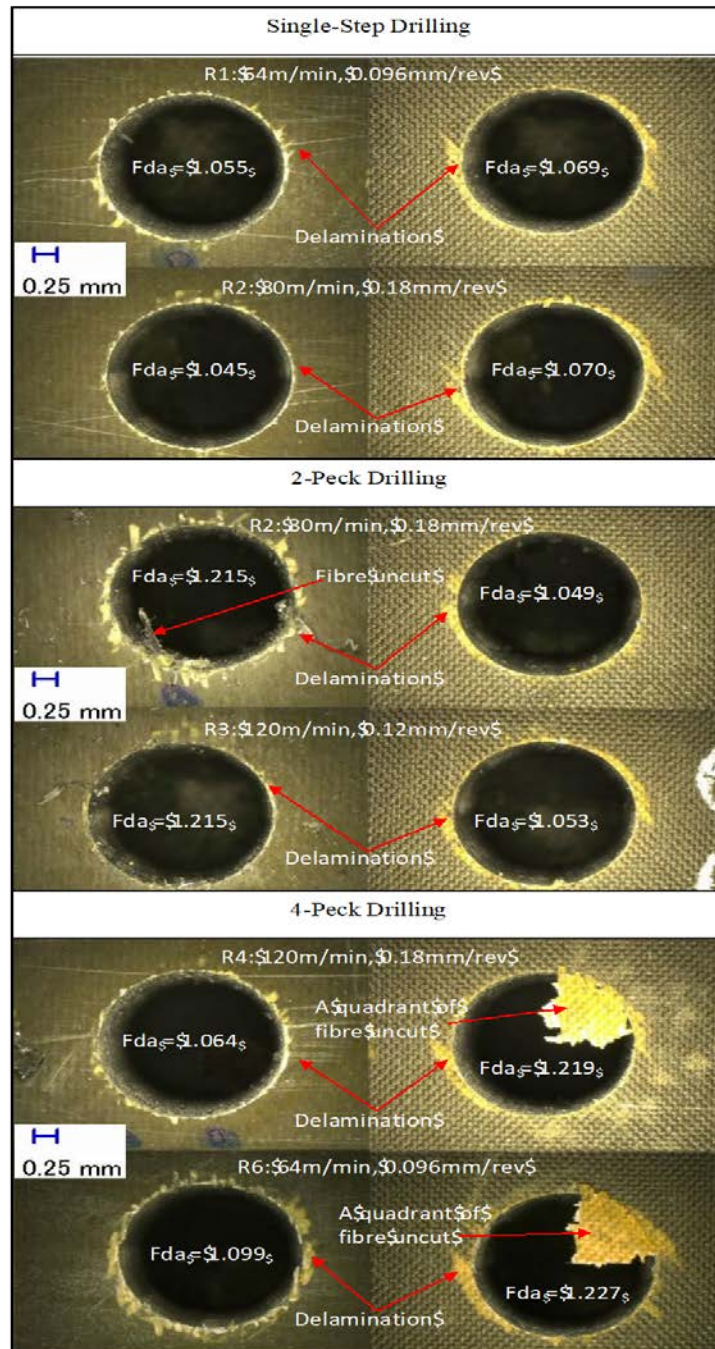
The next series of experiments was conducted to establish whether the hole quality depends solely on one cutting parameter or not. The experiments were done the same way as the previous experiments, however, this time they were conducted in a random sequence. Based on the results in Figure 6, the hole damage was reduced compared to the results shown in Figure 5. In the meantime, the 4-step peck drilling still achieved the least good result compared to the other strategies. These results were confirmed by the values of the delamination factor as provided at the bottom of each hole image. Furthermore, the results indicate that hole quality does not depend solely on one cutting parameter.

**Figure 6** Image results of drilling strategies in random manner.

Peck drilling strategies were discarded for the next experiments due to the positive results of the single-step strategy. That the hole defects were significantly reduced by changing the sequence means that the change in hole quality could not be associated with the alteration of one single process parameter (i.e. increase/decrease of speed or feed rate). Hence, it is likely that the hole quality was also affected by the progression of tool wear.

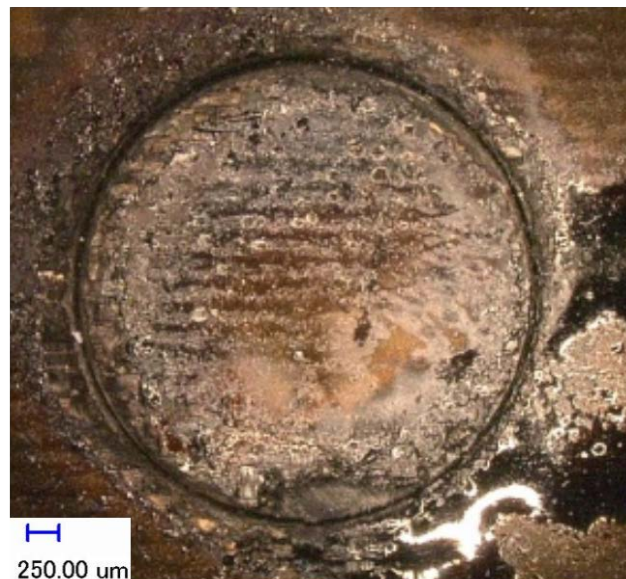
Initially, it was decided to focus only on laser power and scanning speed to determine the processing window for single-pass cutting. Figure 8 shows the attempt of laser drilling, which was unsuccessful in penetrating the workpiece, even though the experiments were conducted with variation of laser power and scanning speed. A significant amount of HAZ appeared at the outer region of the hole circumference. Then, another experiment was conducted to investigate how far the laser could penetrate the 25.4 mm thick CFRP workpiece in multiple passes at different depths, since the earlier tests were unsuccessful in cutting through the entire block in a single pass.

**Figure 8** Initial laser drilling result (power: 900 W; speed: 10 mm/sec; single pass).
